## Chip Loss during installation.

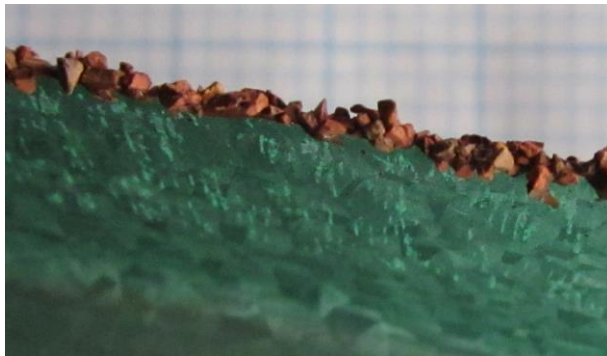
Stone granules at the edge of a tile, this may be removed during installation and handling. This chip may end up being washed down into the gutter.

- There will be a small amount of stone granules loss during the installation process.
- The stone granules are applied to the basecoat and then the excess is removed before the tile is coated in overglaze. Granules adhering to the top surface of the tile are strongly bound and will only be removed during installation if the surface is damaged through poor installation technique.
- Stone granules that may come loose will have been attached to the edges of the tiles. Basecoat is applied in a thick coating that wraps over the edges of the tiles. Granules that adhere to the basecoat on the edge is only held by a fraction of the granules surface so it is easily knocked off during handling and installation of the tiles.

This small amount of chip will eventually be washed down into the rain water gutter.  
This is the only chip loss that will be seen for many years.
