Aluminium Zinc Substrate Performance.

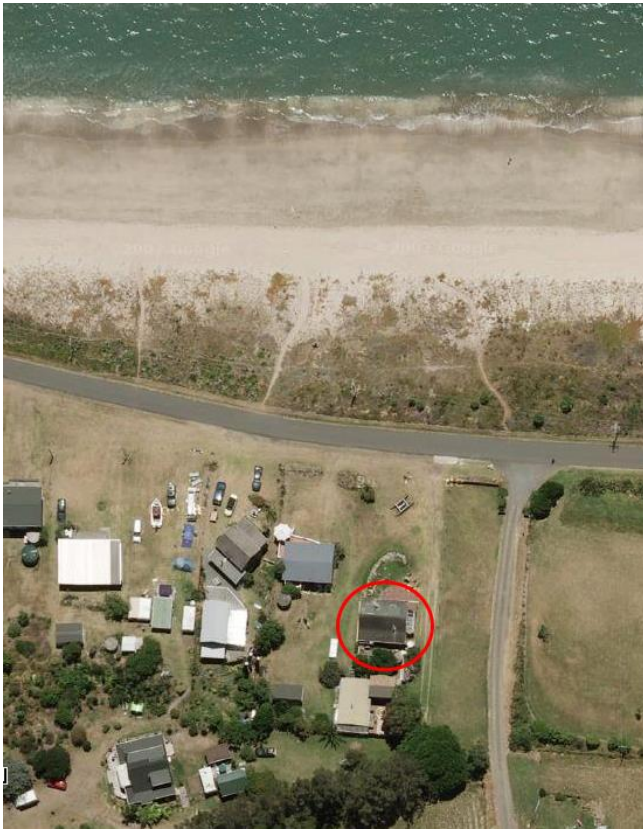
AHI Roofing - 30 year marine site roof exposure location

AHI Roofing have had Aluminium Zinc tiles on exposure in a marine environment for 30 years. In that time tiles have been removed from a roof at 8, 15, 20, 25 and 30 years. The substrates Aluminium Zinc coating has been analysed, after 25 years the projected life expectancy was 75 years, however after 30 years the level of Aluminium Zinc remaining had not deteriorated any further than the 25 year sample. The roof has out lasted pre-painted Galvanised steel on roofs and accessories next door to this roof which were replaced after 25 years.

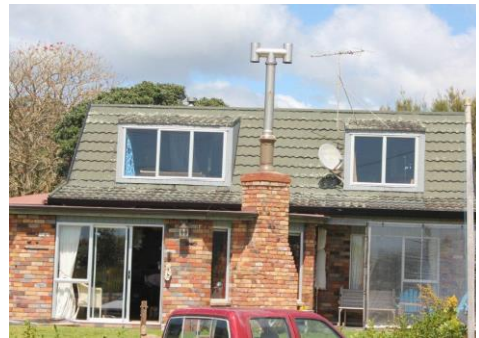
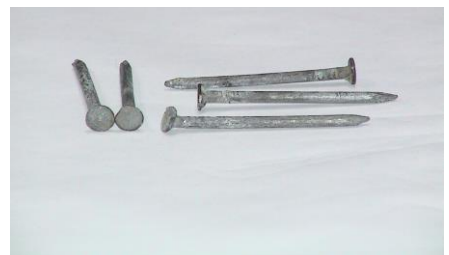
Galvanised nails

Edge or scratch damage corrosion spots are protected by the zinc that is close to the damaged area as well as the little understood small cathode/ large anode principle where little corrosion occurs to an edge of steel (small cathode) in the present of a large galvanic coated surface (large anode). This also helps explain why nails (galvanised) that have little protection from the elements remain in good condition for so long.

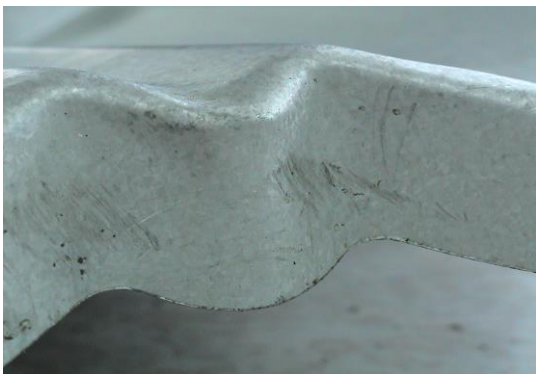
Tile nose edge

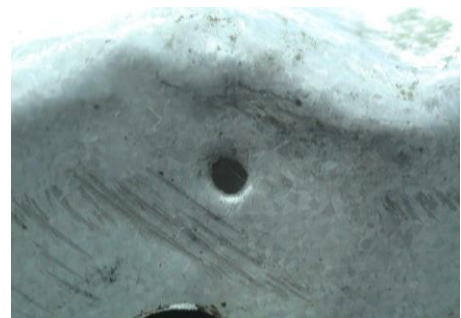
Nail hole

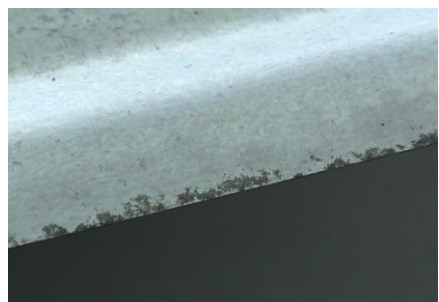
Underside of overlapped section edge corrosion
